Variable Leak Rate Phenomena in Glass to Metal Seals

R.A. Clarke, Teledyne Electronic Technologies (TET)
Phone (805) 574-2064, Fax (805) 577-3808
A. DerMarderosian, Raytheon
Phone (781) 642-3443, Fax (781) 642-3949

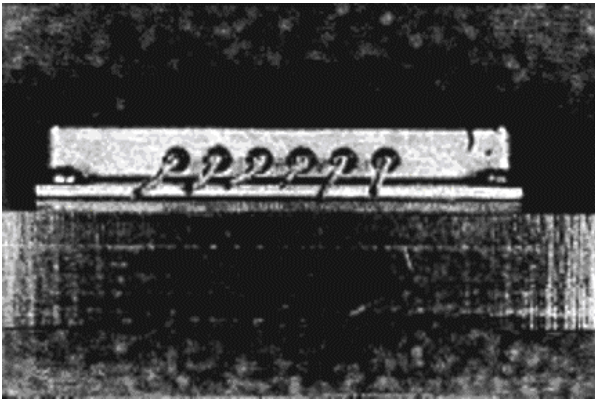
Figure 1

The hybrid in question was constructed in a molybdenum based power package with 12 copper leads, butt welded to Kovar feedthroughs (see Figure 1). The package was felt to be of robust design and had never failed RGA previously. The RGA results were obtained as part of a DPA by the customer and are shown in Table 1 along with the data from a subsequent confirmation DPA test as well as data from 5 samples rejected at TET as x-ray failures.

Side View of Power Package RGA Failure

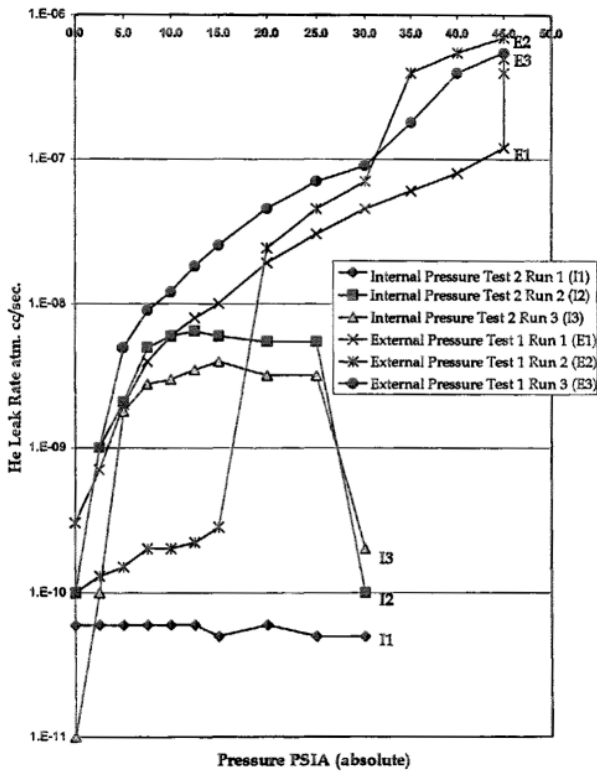
Figure 3 - Teledyne Hybrid S/N 22
Helium Leak Tests at 22°C

The results of the variable pressure tests at 22°C are plotted in Figures 3-4. The graph in Figure 3 shows that S/N 20 was extremely pressure sensitive, although somewhat erratic. The leak rate variations produced with external pressure were not reproduced on the initial internal pressure run. On the next two runs however a 15 fold increase in leak rate was observed at pressures up to 25psia that disappeared as the pressure exceeded 25psia.

S/N 20 is clearly a pressure sensitive leaker. The exact leak rates appear to vary depending on the history of the unit. This is hardly unexpected given the peculiar nature of the leak path. The values of the leak rates shown are qualitatively consistent with

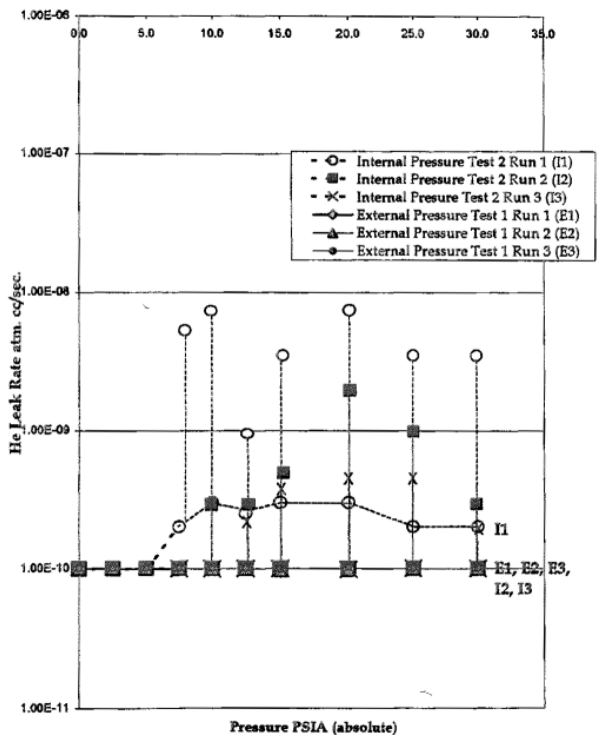
Figure 4 - Teledyne Hybrid S/N 56
Helium Leak Tests at 22°C

The data in Figure 4 shows that S/N 56 had no leak rate dependence on external pressure. An unexplained transient leak rate was observed, however, under internal pressure conditions. This "burst" leakage occurred for short periods at 5×10^{-9} Atm. cc/sec level before settling at a steady 4×10^{-10} Atm. cc/sec level on the first run. The burst behavior only was observed on the other runs.
